ARROWHEAD LAKE DAM

NDI NO. PA-00780
DER NO. 45-207

PHASE I INSPECTION REPORT
NATIONAL DAM INSPECTION PROGRAM

AUGUST 1980

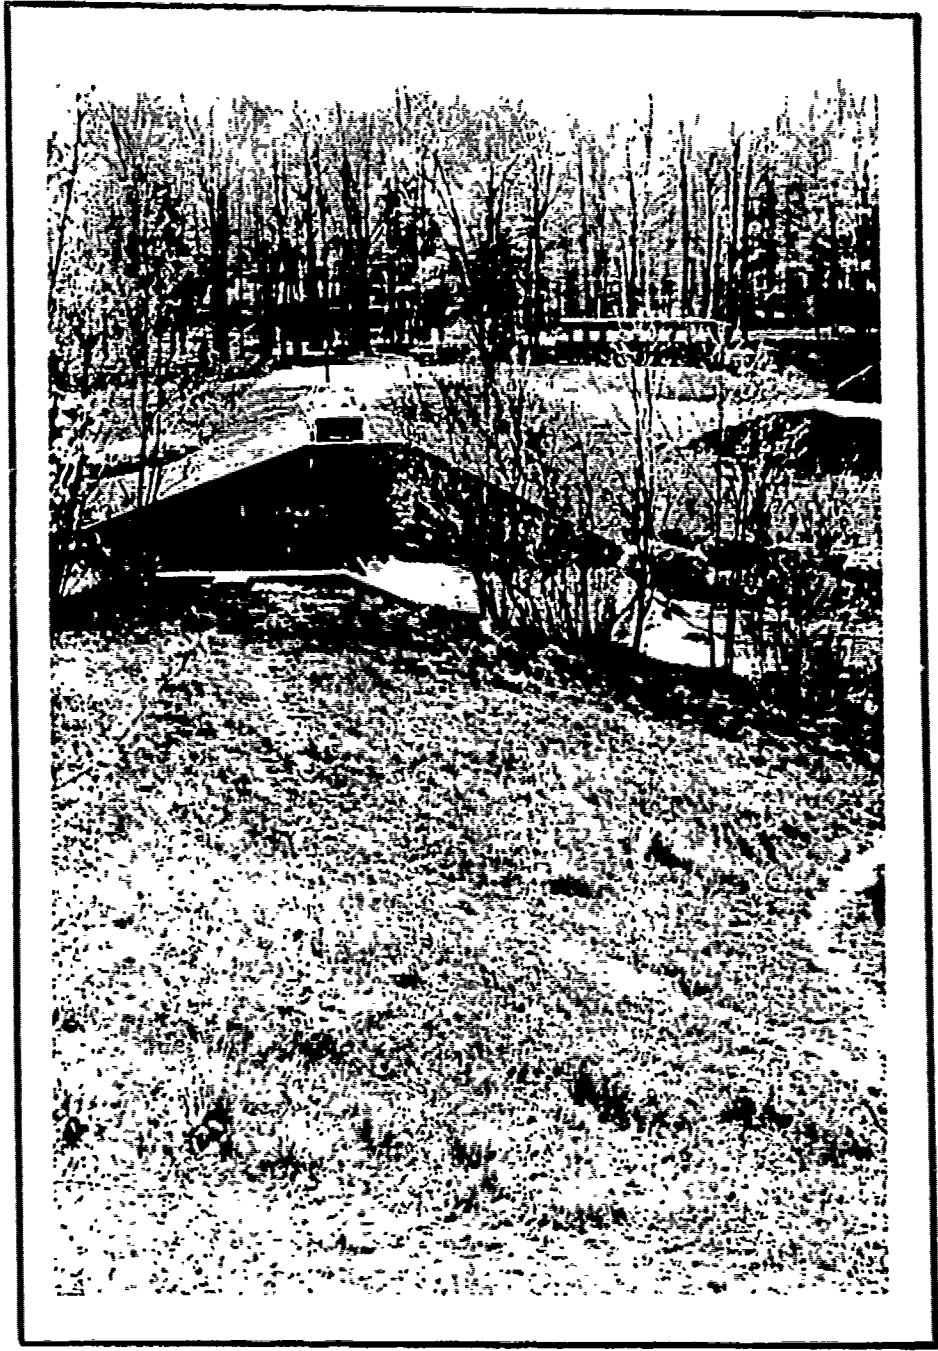
Photograph No. 1

OVERVIEW

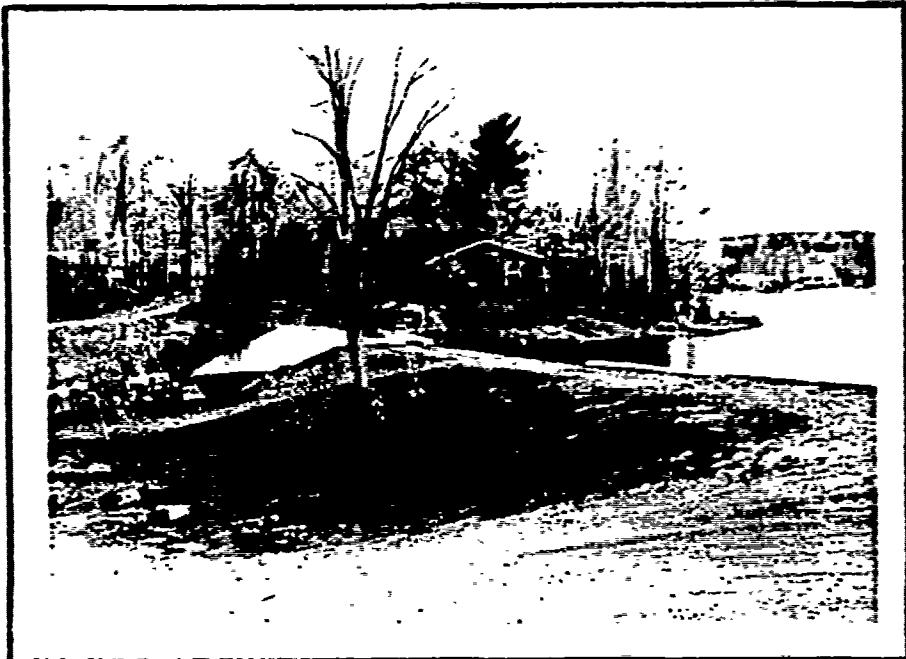
E. RIPRAP FAILURES	No exposed riprap on slope. Riprap is covered with soil and grass.
F. JUNCTION EMBANKMENT & ABUTMENT OR SPILLWAY	Abutments are sound. Embankment 9"-12" below top of wall on left side. Some erosion adjacent to spillway wall on left side - both upstream and downstream.

DOWNTSTREAM SLOPE LEFT ABUTMENT - NO. 2

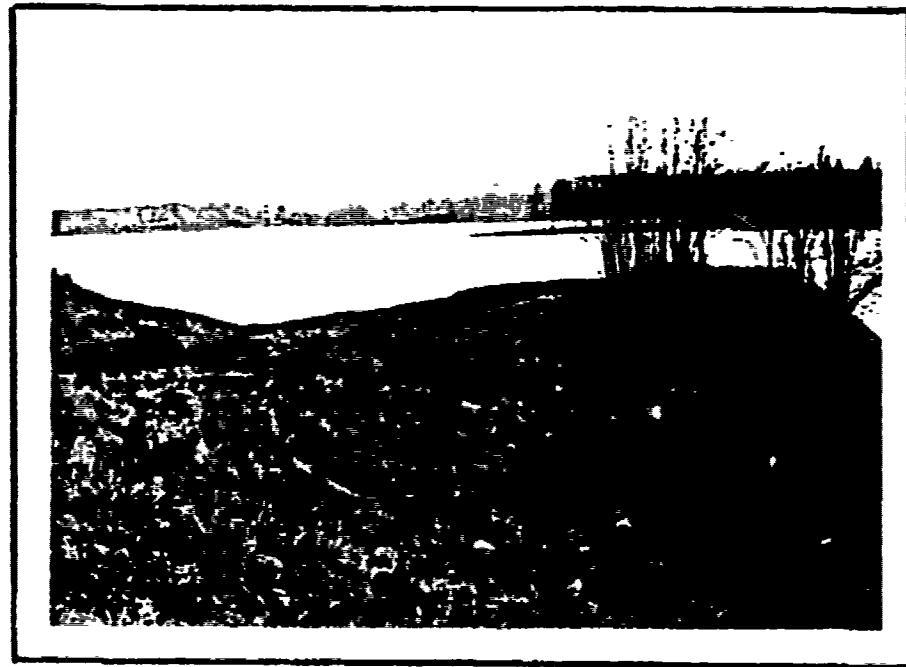
The stoplog structure is in fair condition. The overall condition of the spillway is good. The blowoff pipe at the right side of the spillway is not operable. The outlet for this pipe is buried.

G. SEEPAGE	None on left side. Pipe on right side. Either buried valve leaking or seepage along pipe.
H. DRAINS	None.
J. GAGES & RECORDER	None.
K. COVER (GROWTH)	Mowed lawn on both slopes and crest. Some bare spots on crest.

LOW AREA RIGHT OF SPILLWAY - NO. 3
NOTE VALVE IN FOREGROUND

3. That the downstream end of the blowoff pipe be uncovered and the pipe be made operable. This pipe should be modified to have an upstream control.
4. That the wet area downstream of the blowoff pipe be monitored on a regular basis. If an increase in volume or any turbidity is observed, immediate steps shall be taken to identify and correct the condition.

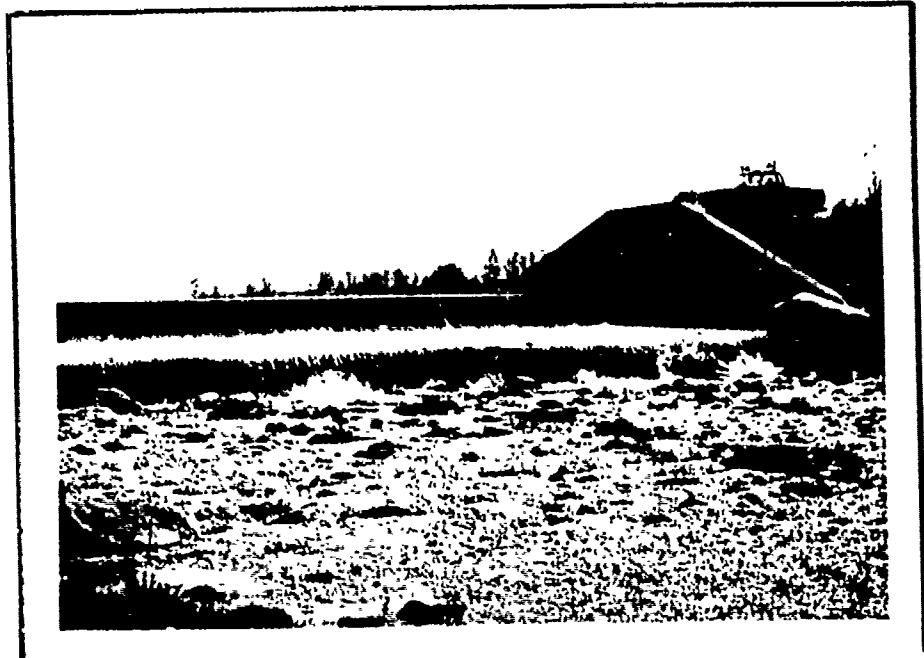
both sides of the ogee section and apron. All concrete is in good condition. The right spillway wall is one foot lower than the design elevation. There is a wide construction joint between the ogee section and the apron. A 2.5 foot drop-off is located at the downstream end of the apron. Cavitation has occurred at the end of the apron slab. The downstream channel has several large boulders along the banks just downstream of the apron. One of these has rolled into the channel (Photograph No. 6).

C. DISCHARGE CHANNEL: Lining Cracks Stilling Basin	Concrete slab to about 30' ± downstream from toe of ogee. Concrete wing walls. Discharge channel below concrete structure is the natural stream. Rock bottom. End of slab shows cavitation under slab over most of its length up to 8 inches deep. Large boulders on both sides of channel at end of wing walls. One big boulder at end should be removed. Some <u>rap protection to be placed at end of wing.</u>

SPILLWAY LOOKING UPSTREAM - NO. 6
